Breaking Thunderbolt Protocol Security: Vulnerability Report

Björn Ruytenberg
Eindhoven University of Technology
`bjorn@bjornweb.nl`

April 17, 2020

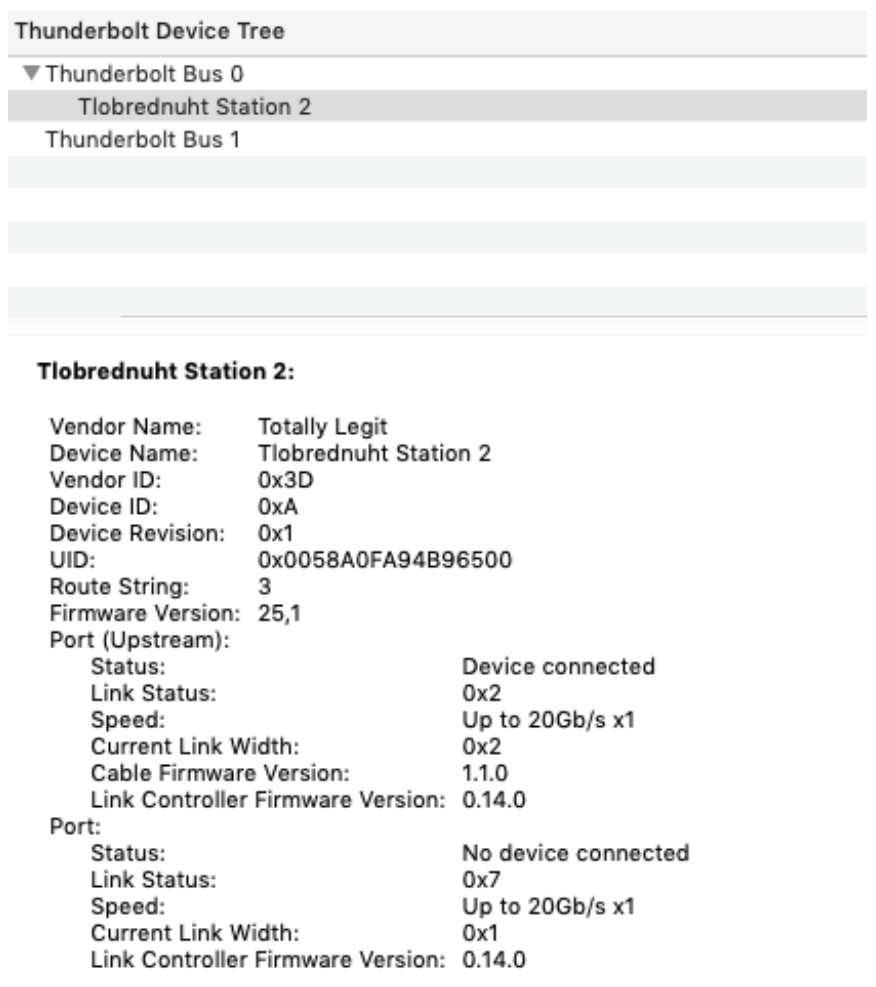
3. **Use of unauthenticated device metadata.** Thunderbolt controllers store device metadata in a firmware section referred to as *Device ROM (DROM)*. We have found that the DROM is not cryptographically verified. Following from the first issue, this vulnerability enables constructing forged Thunderbolt device identities. In addition, when combined with the second issue, forged identities may partially or fully comprise arbitrary data. Figure 2 demonstrates a device passing authentication while presenting a forged DROM to the host.

Figure 2: A Thunderbolt device presenting a forged DROM.

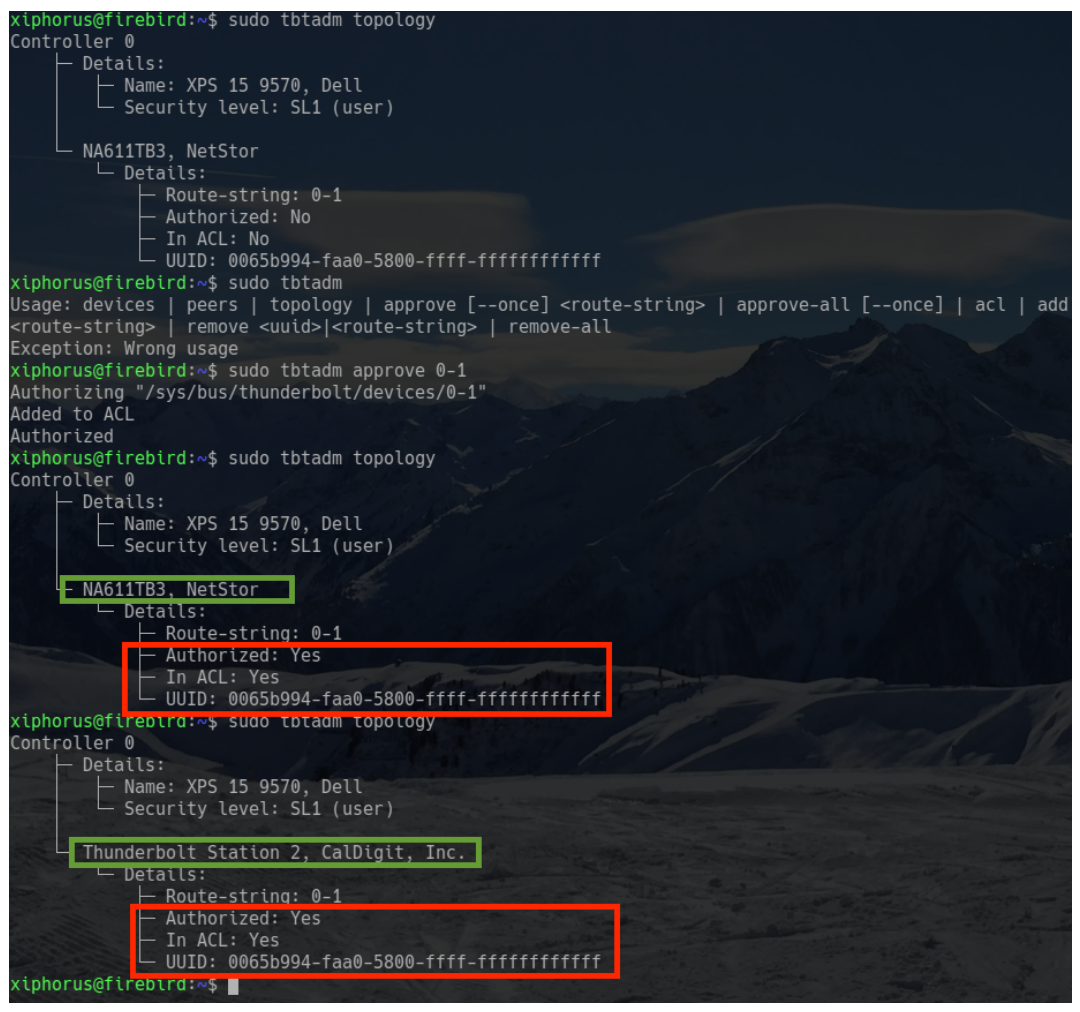
Figure 3: An attacker-controlled device spoofing the identity of a victim device on Linux.

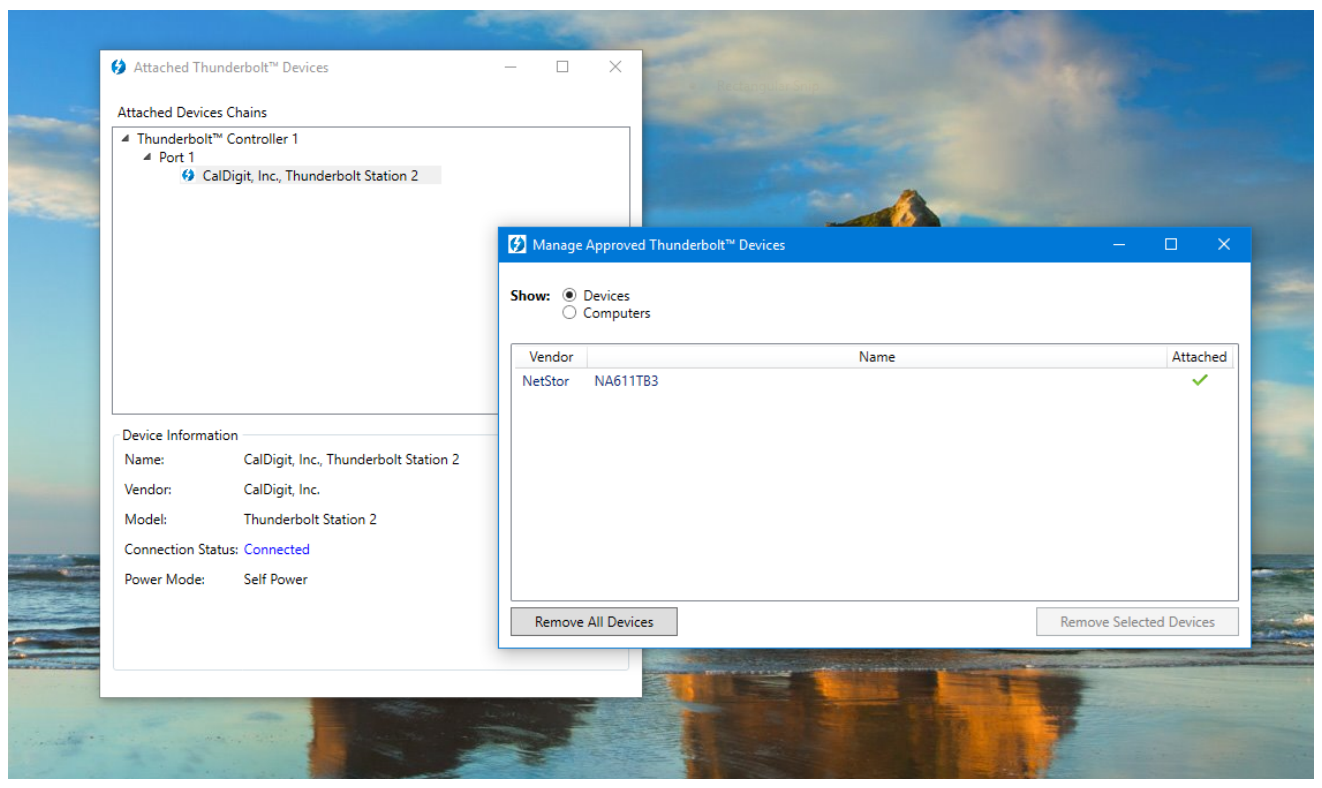
Figure 4: An attacker-controlled device cloning the identity of a victim device on Windows.

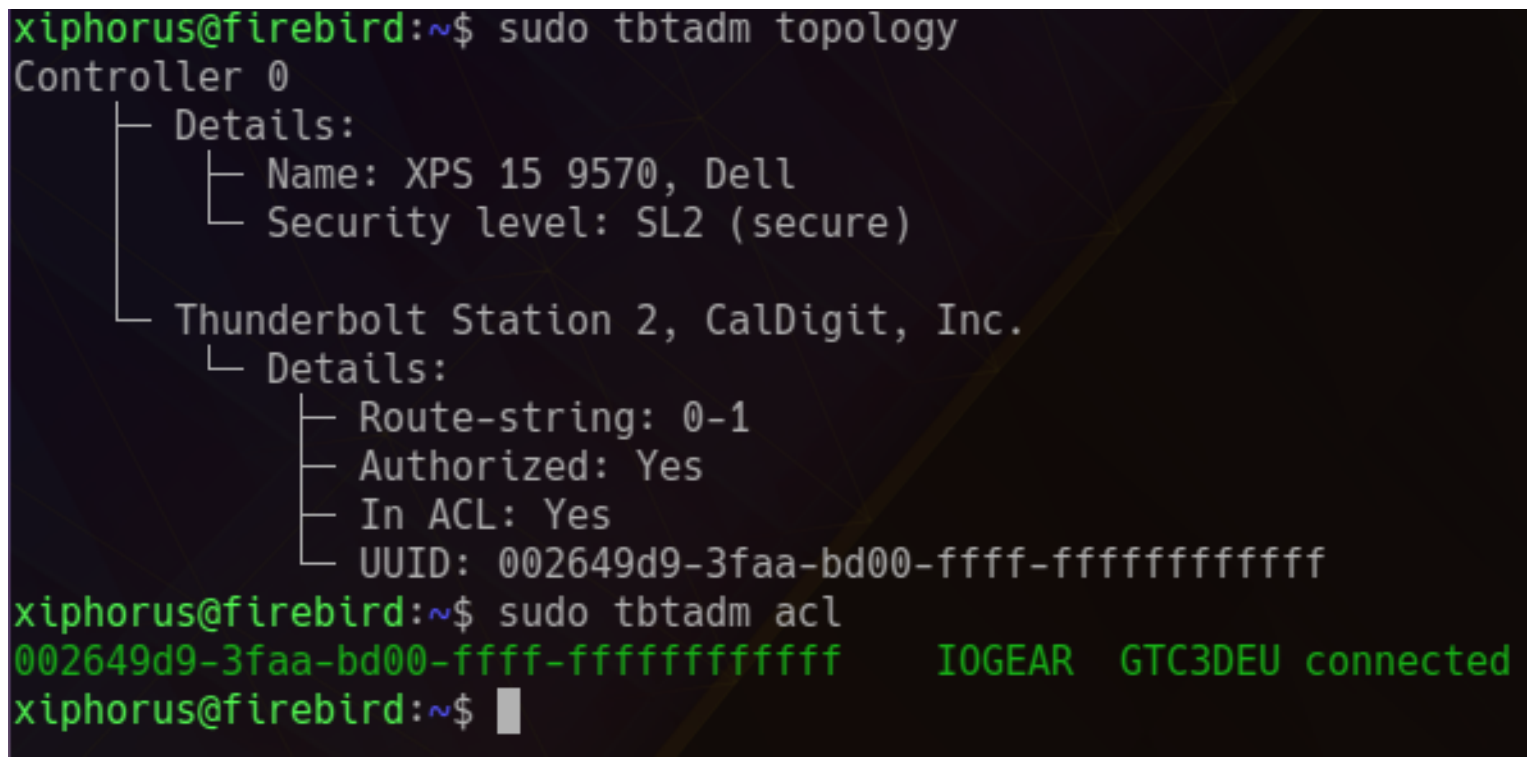
Figure 5: Spoofing a victim device while employing the “Secure” Security Level.

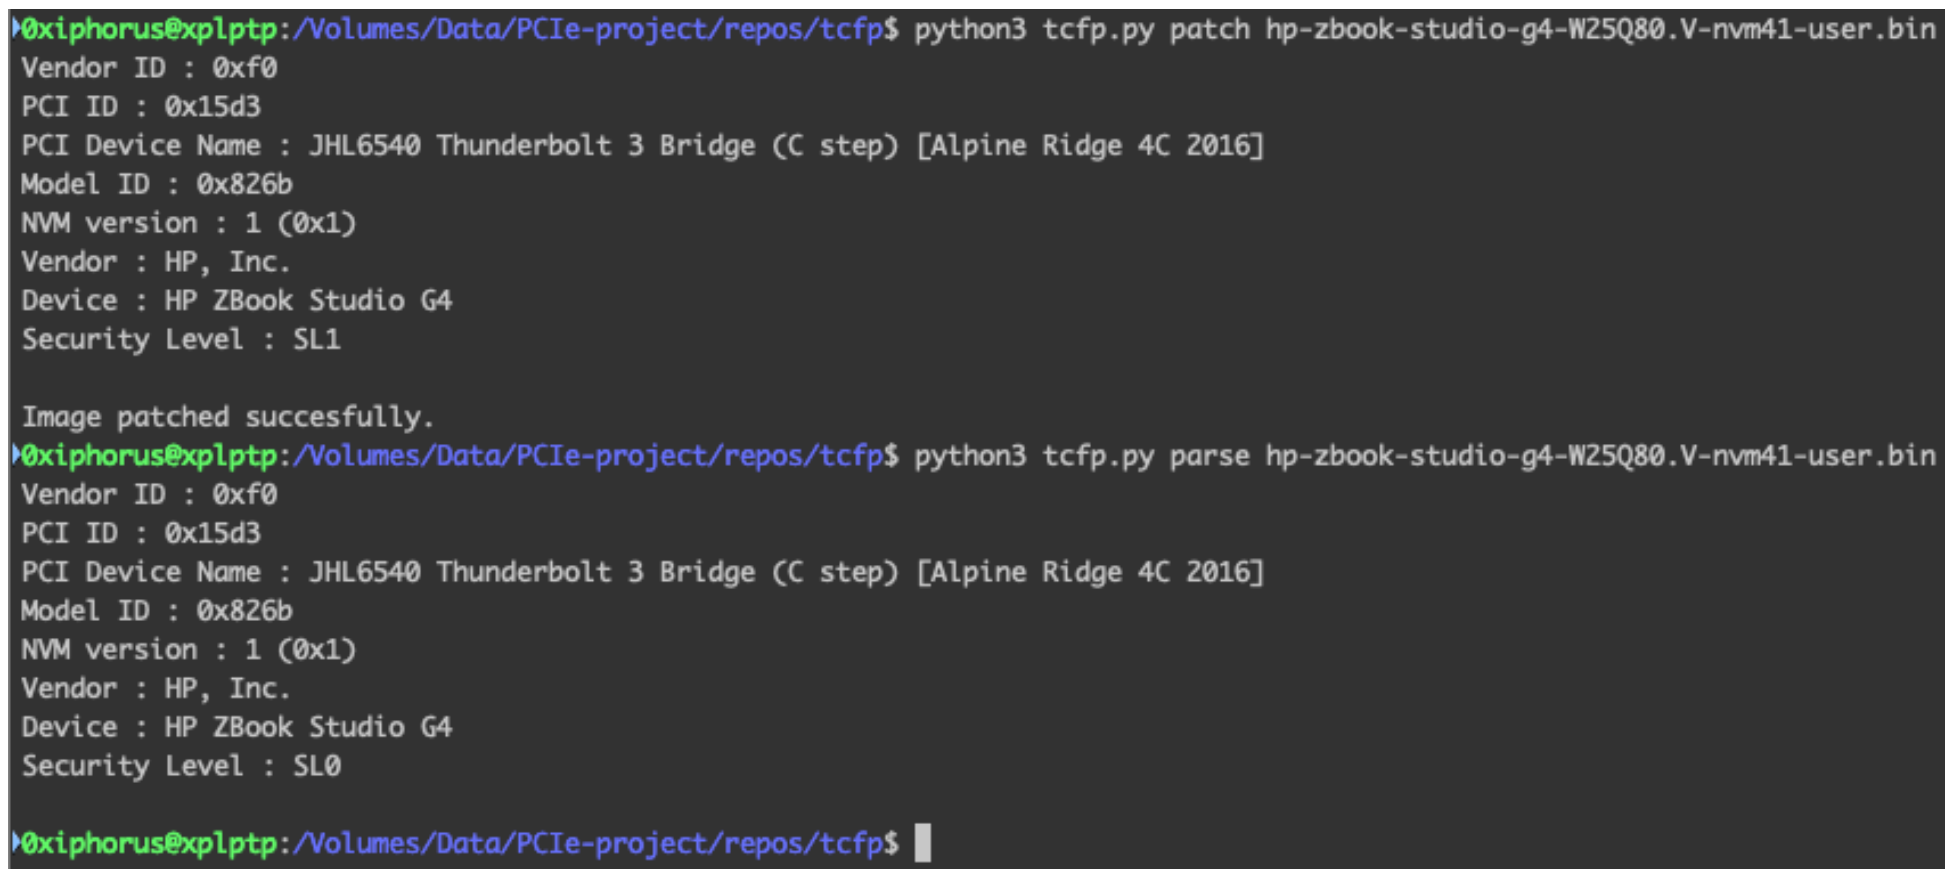
Figure 8 shows example output for a host controller originally configured to employ the default Security Level "User" (SL1). Similarly, Figure 9 lists example output for a host controller initially configured to disable Thunderbolt connectivity, that is, exclusively pass through DisplayPort and USB (SL3).

Figure 8: Altering firmware image to patch Security Level configuration from "User" (SL1) to "None" (SL0).

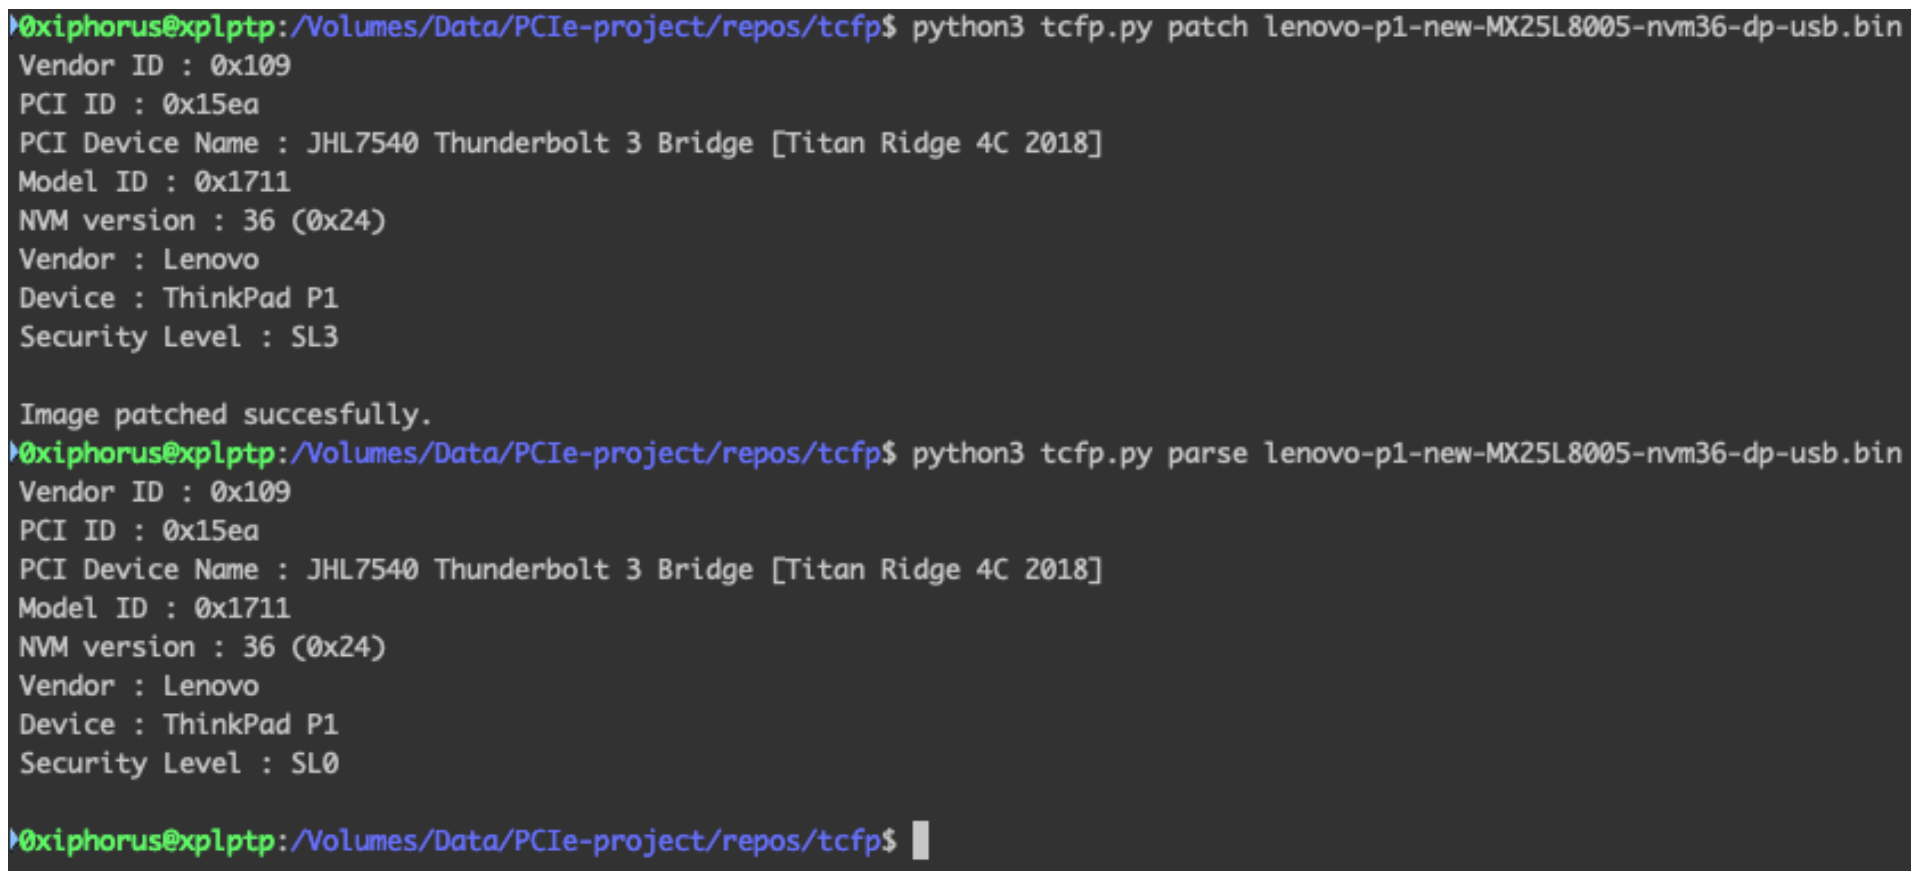
Figure 9: Altering firmware image to patch Security Level configuration from “No PCIe tunneling” (SL3) to “None” (SL0).
